Client:	AGL Macquarie Pty Limited
Project:	Phase 1 Preliminary Environmental Site Assessment – Tomago Development Site, NSW
Project Number:	15107
Report Title:	Volume 5 of 7: Phase 1 Preliminary Environmental Site Assessment - Tomago Development Site, Tomago NSW
Date:	9 January 2017
Document Name:	15107RP01 TDS APECS PESA FINAL
Revision Number	0
Written By: Greg Sheehan Environmental Scientist	GCG
Reviewed By: Craig Wellings Principal Environmental Scientist	Claff.
Reviewed By: Rod Harwood Principal Hydrogeologist	(Denwood

4.12	Quality of Surface Water	28	
AGL M	Additional Pre-Existing Contamina	tion Study	
volum	= 5 of 7 = 1000 ago Development site, is siven in structure of the second site	JA FIINAL

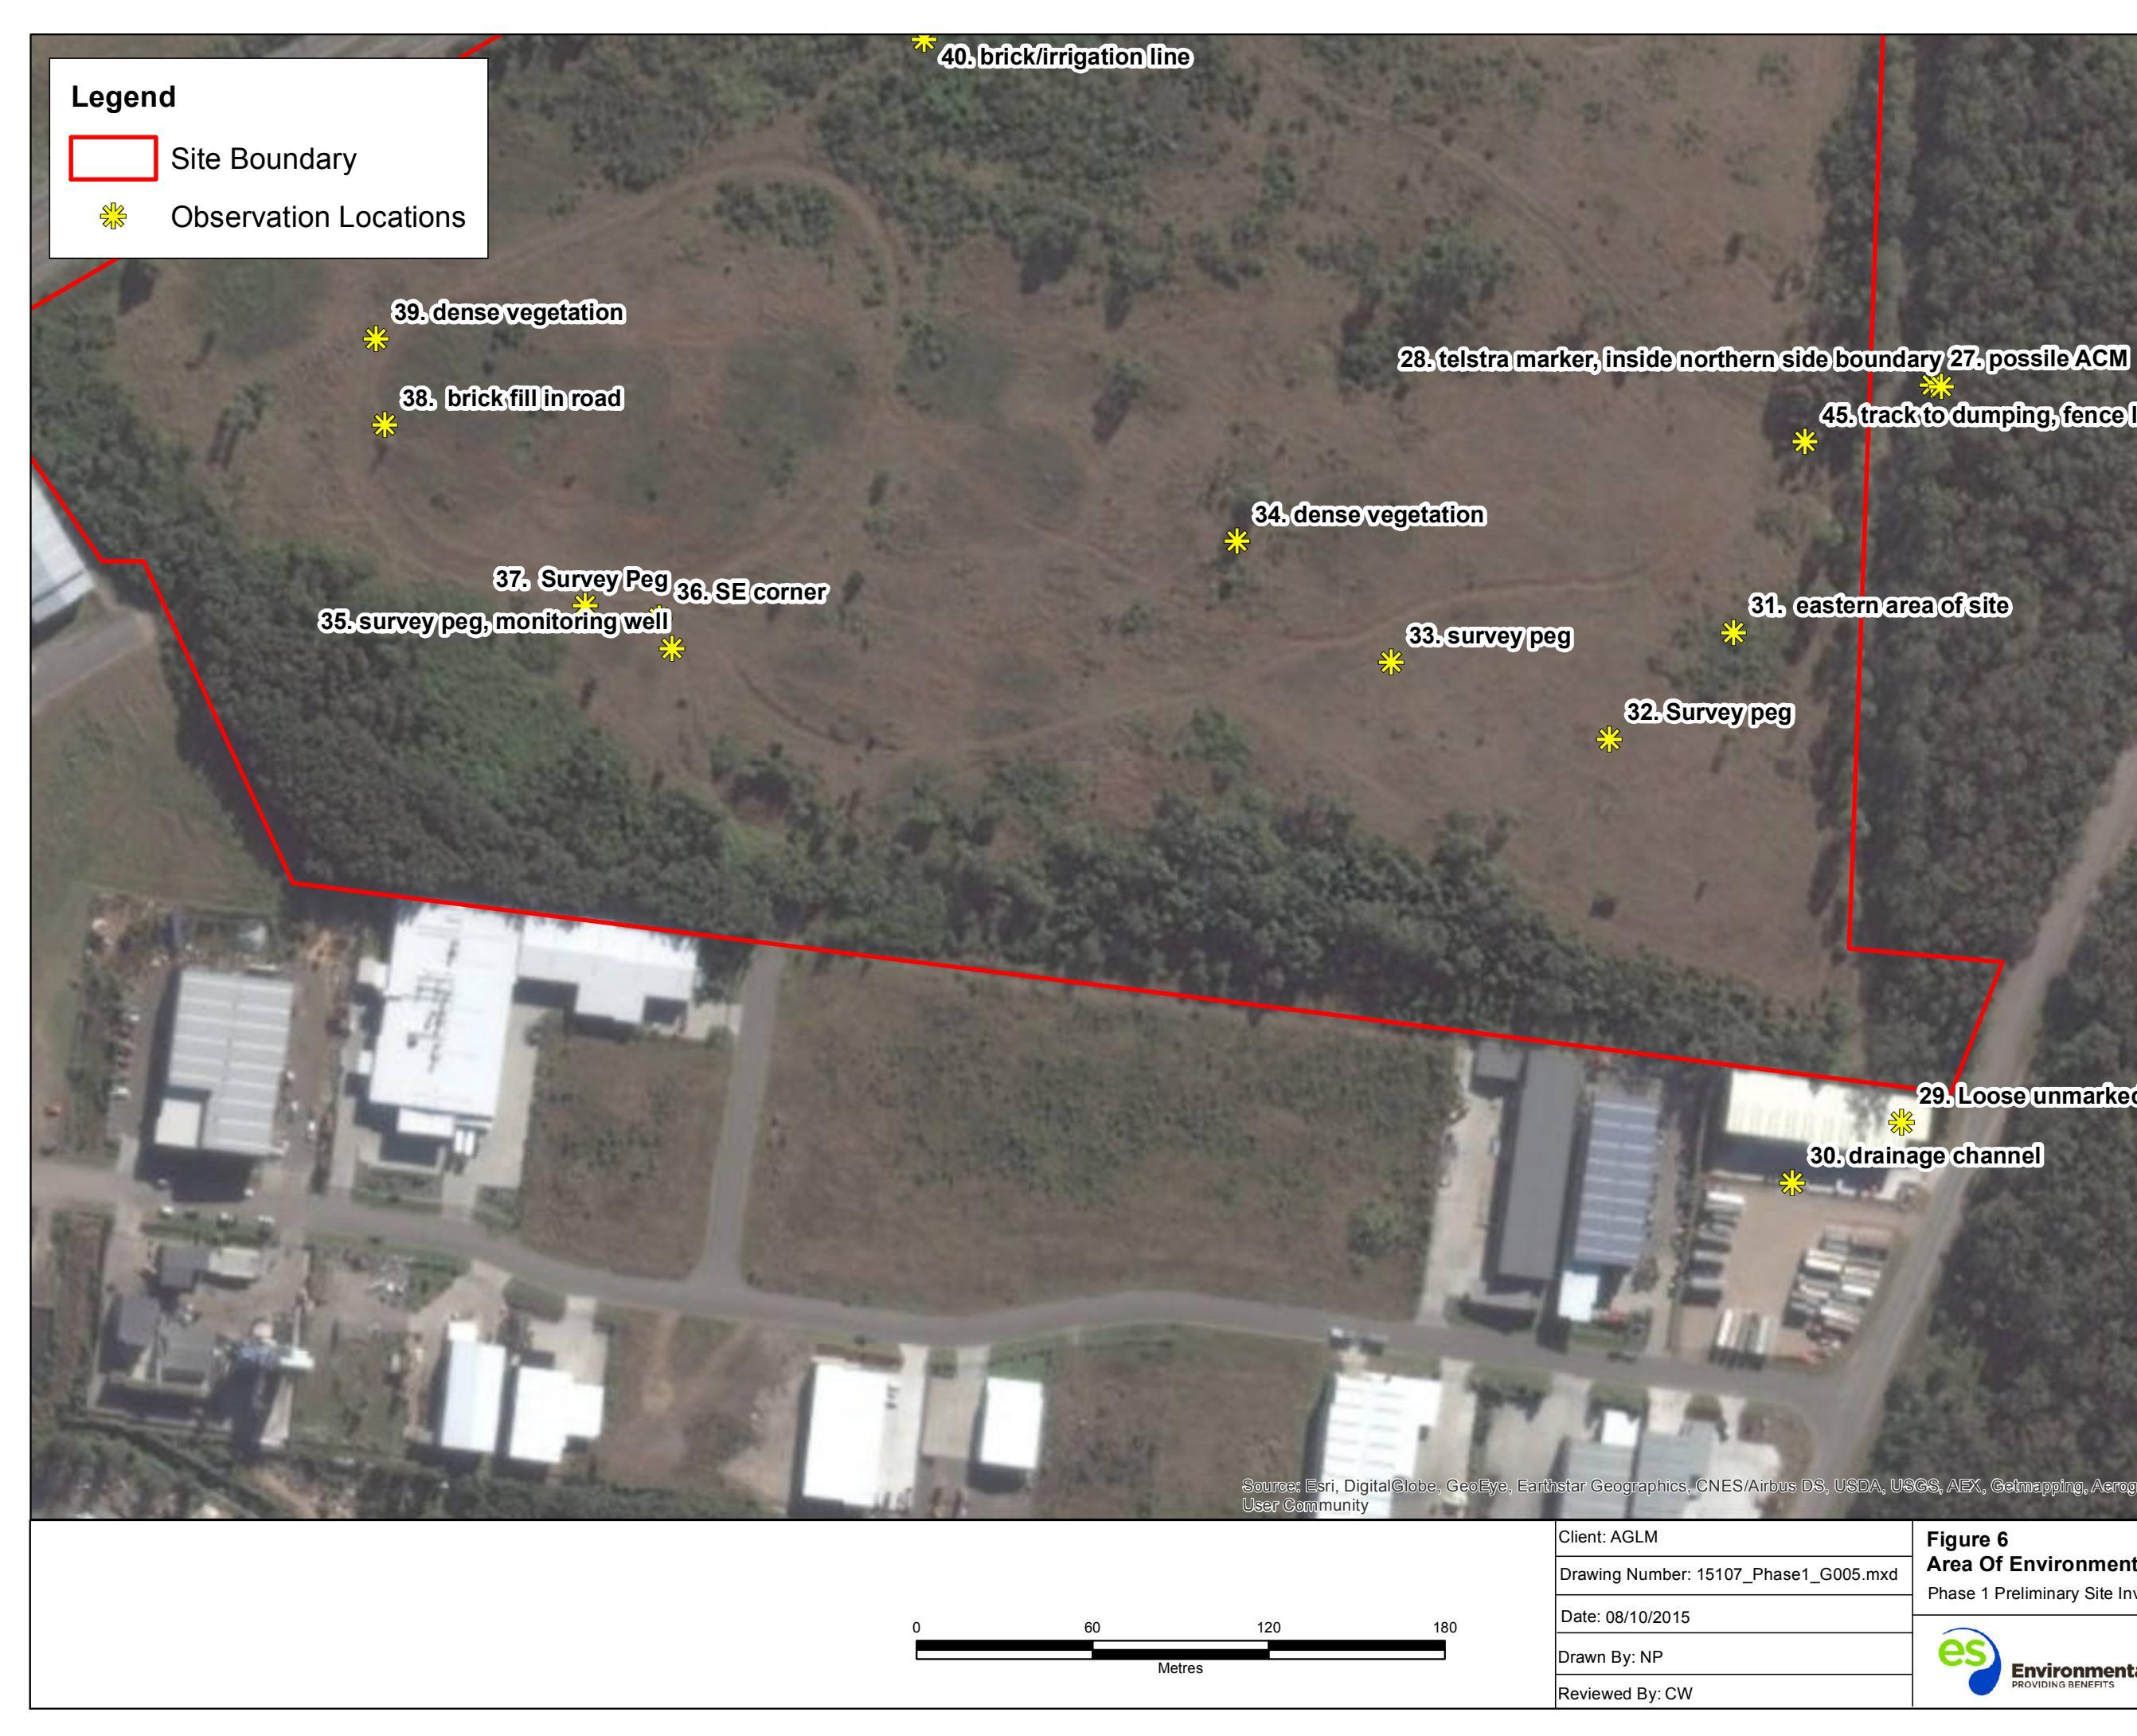
45. track to dumping, fence line from boundary

29. Loose unmarked service line

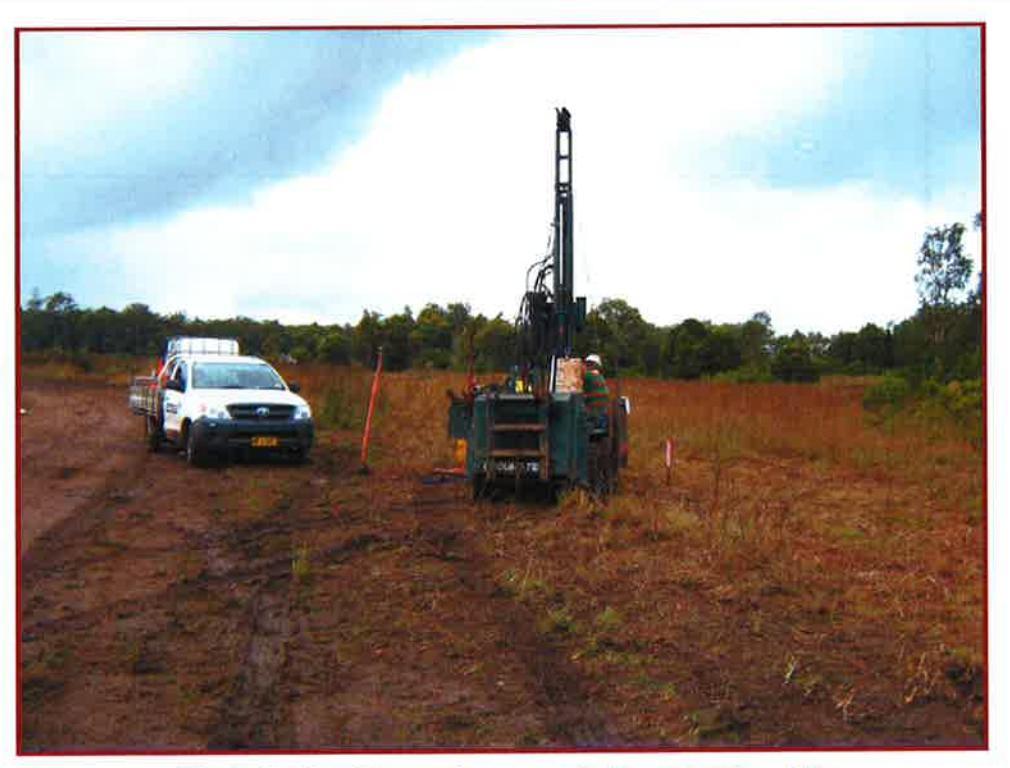
Photo 1 - Looking east across site towards Bore 118

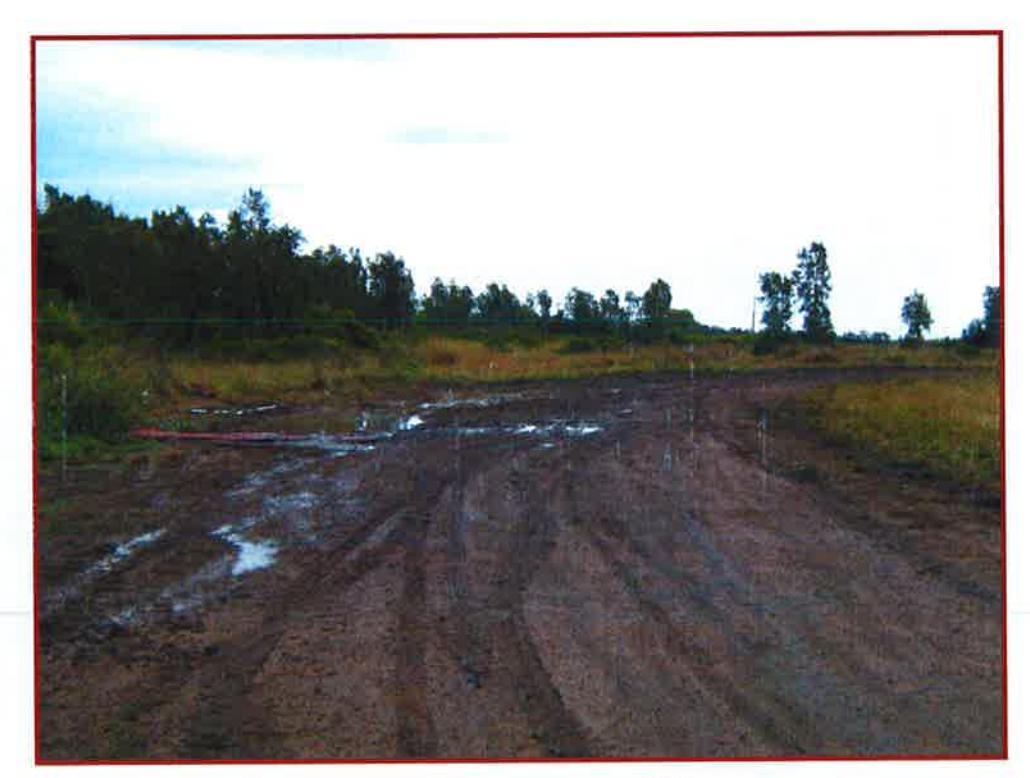
Photo 2 – Looking west across site towards Bore 112

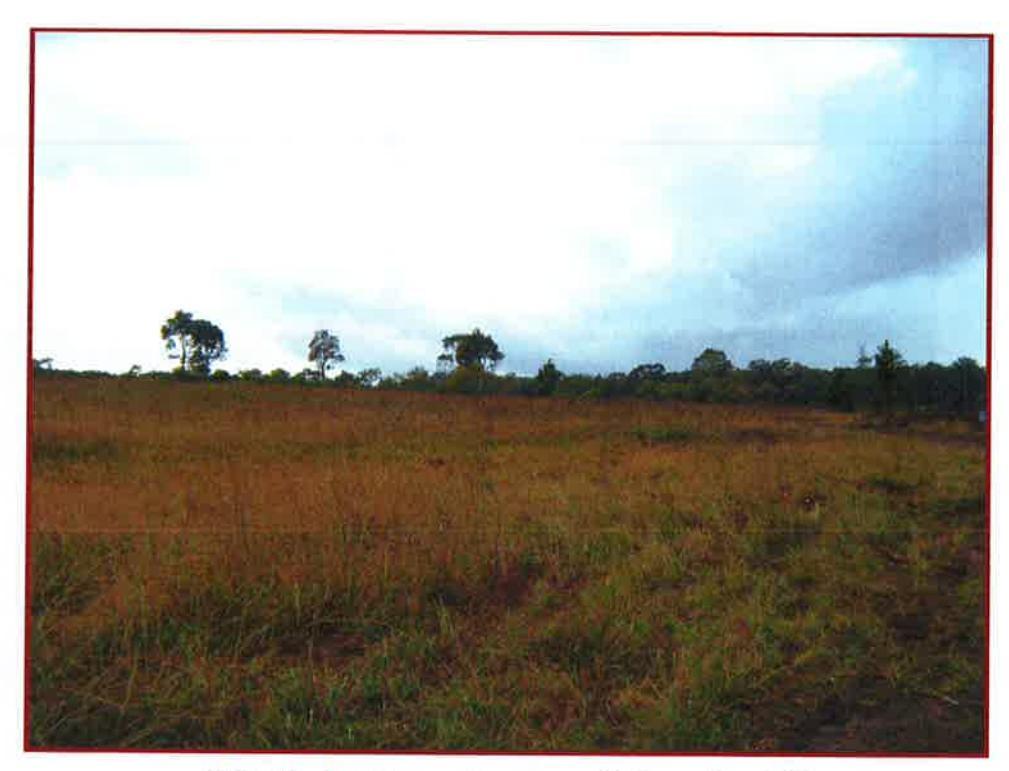
Photo 3 – Looking north across site from Bore 131

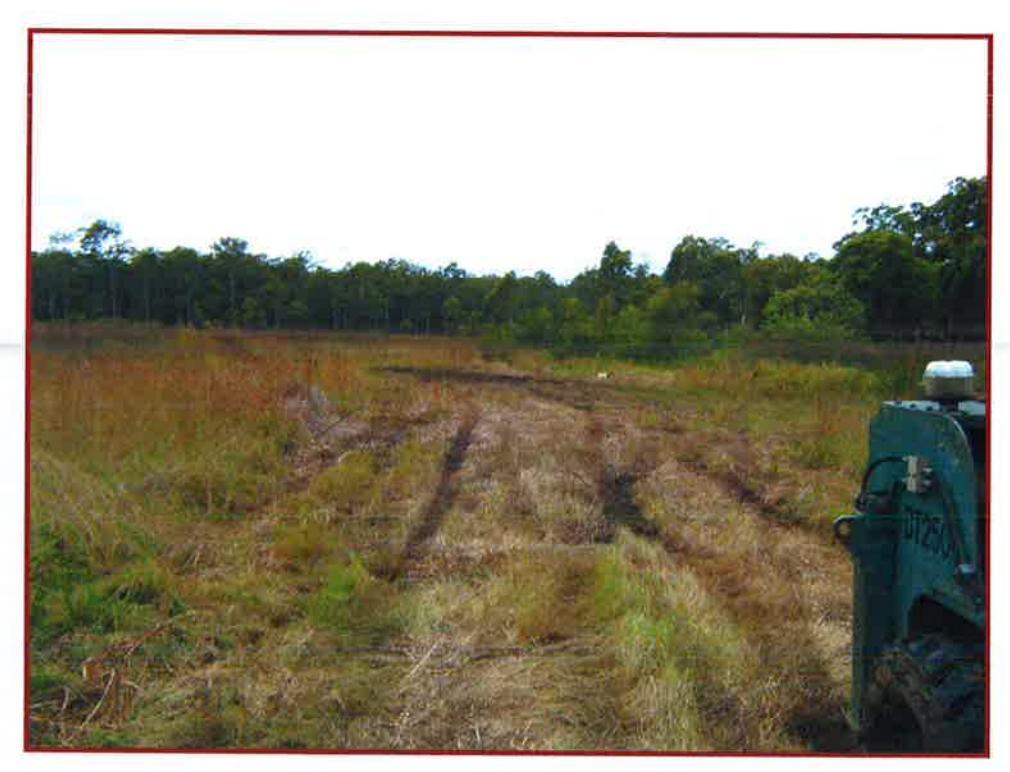
Photo 4 – Looking east across site towards Bore 134

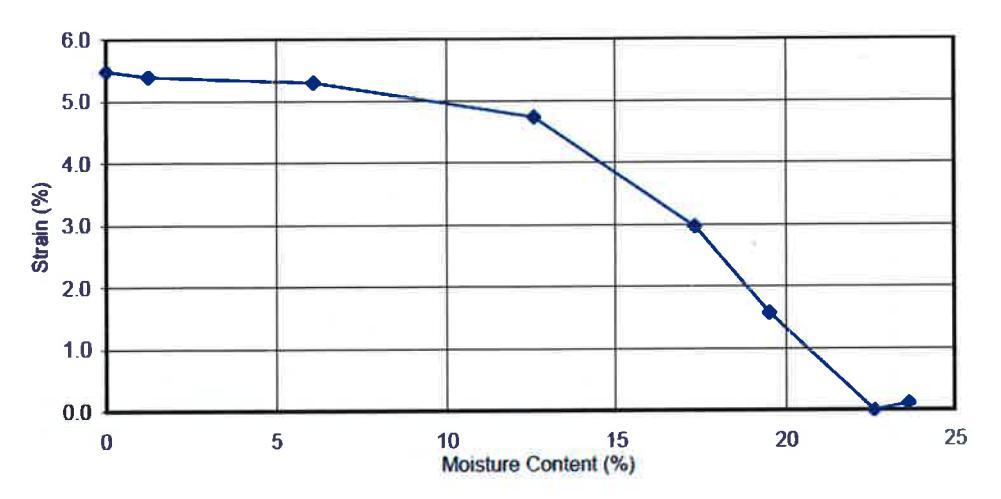
Shrinkage - air dried	5.4 %	Pocket penetrometer reading at initial moisture content	300 kPa
Shrinkage - oven dried	5.5 %	De elect per etterpreter reading	150 kDa
	A 121 O/	Pocket penetrometer reading	IDU KPd
Significant inert inclusions	NII %	at final moisture content	
Extent of cracking	SC	Initial Moisture Content	24.3 %
Extent of soil crumbling	Nil %	Final Moisture Content	23.6 %
Moisture content of core	22.6 %	Swell under 25kPa	-0.1 %

SHRINK-SWELL INDEX Iss 3.0% per ∆ pF

Description:	Silty CLAY - Brown red	
Test Method(s):	AS 1289.7.1.1 - 2003, AS 1289.2.1.1 - 2005	
Sampling Method(s):	AS 1289.1.3.1-1999	
Extent of Cracking:	UC - Uncracked	HC - Highly cracked
	SC - Slightly cracked	FR - Fractured
Remarks:	MC - Moderately cracked

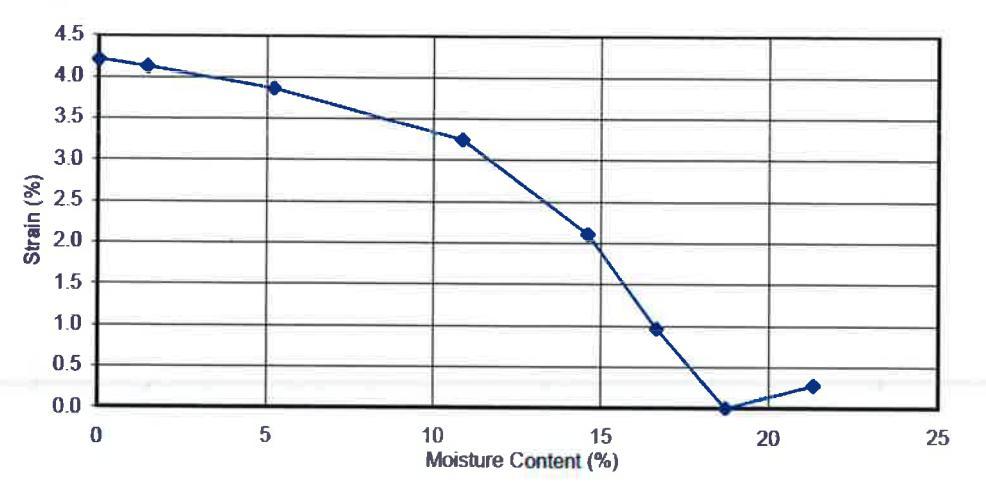
Shrinkage - air dried	4.1 %	Pocket penetrometer reading at initial moisture content	300 kPa
Shrinkage - oven dried	4.2 %		
Significant inert inclusions	Nil %	Pocket penetrometer reading at final moisture content	220 kPa
Extent of cracking	UC	Initial Moisture Content	17.4 %
Extent of soil crumbling	Nil %	Final Moisture Content	21.3 %
Moisture content of core	18.7 %	Swell under 25kPa	-0.3 %

SHRINK-SWELL INDEX Iss 2.3% per \triangle pF

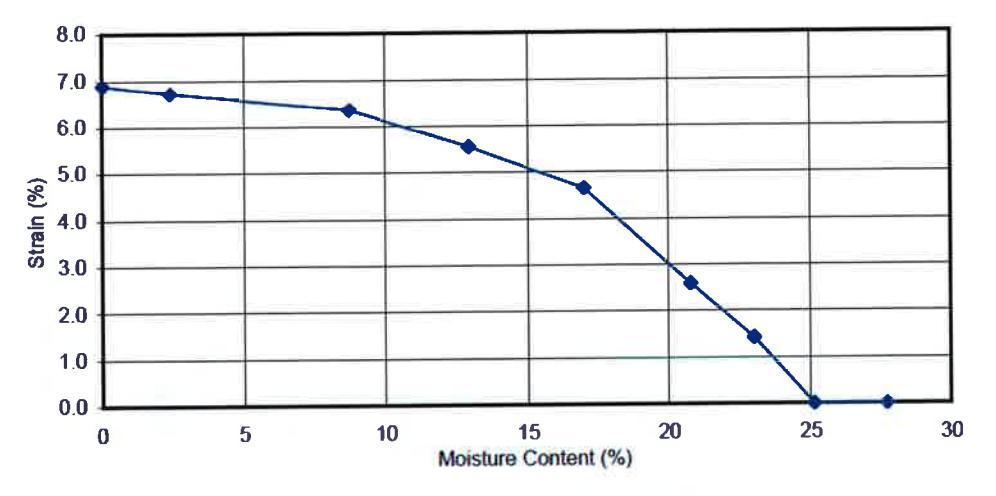
Shrinkage - air dried	6.7 %	Pocket penetrometer reading at initial moisture content	155 kPa
Shrinkage - oven dried	6.9 %	Pocket penetrometer reading	140 kPa
Significant inert inclusions	Nil %	at final moisture content	140 10 4
Extent of cracking	UC	Initial Moisture Content	26.2 %
Extent of soil crumbling	Nil %	Final Moisture Content	27.7 %
Moisture content of core	25.1 %	Swell under 25kPa	0.0 %

SHRINK-SWELL INDEX Iss 3.8% per △ pF

Description:	CLAY-Brown grey mottled red	
Test Method(s):	AS 1289.7.1.1 - 2003, AS 1289.2.1.1 - 2005	
Sampling Method(s):	AS 1289.1.3.1-1999	
Extent of Cracking:	UC - Uncracked SC - Slightly cracked	HC - Highly cracked FR - Fractured
Remarks:	MC - Moderately cracked

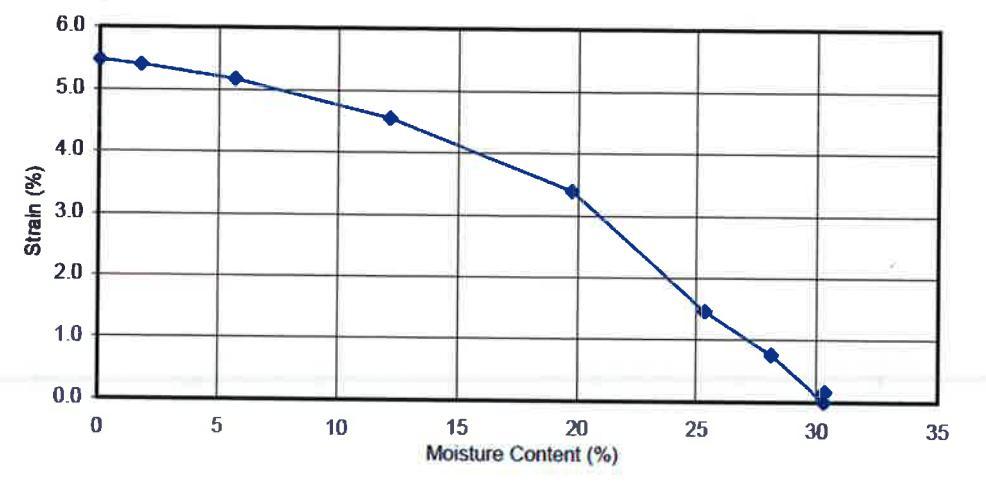
Shrinkage - air dried	5.4 %	Pocket penetrometer reading	240 kPa
Shrinkage - oven dried	5.5 %	at initial moisture content	
Significant inert inclusions	Nil %	Pocket penetrometer reading at final moisture content	120 kPa
Extent of cracking	MC	Initial Moisture Content	30.8 %
Extent of soil crumbling	5.0 %	Final Moisture Content	30.3 %
Moisture content of core	30.3 %	Swell under 25kPa	-0.2 %

SHRINK-SWELL INDEX Iss 3.0% per △ pF

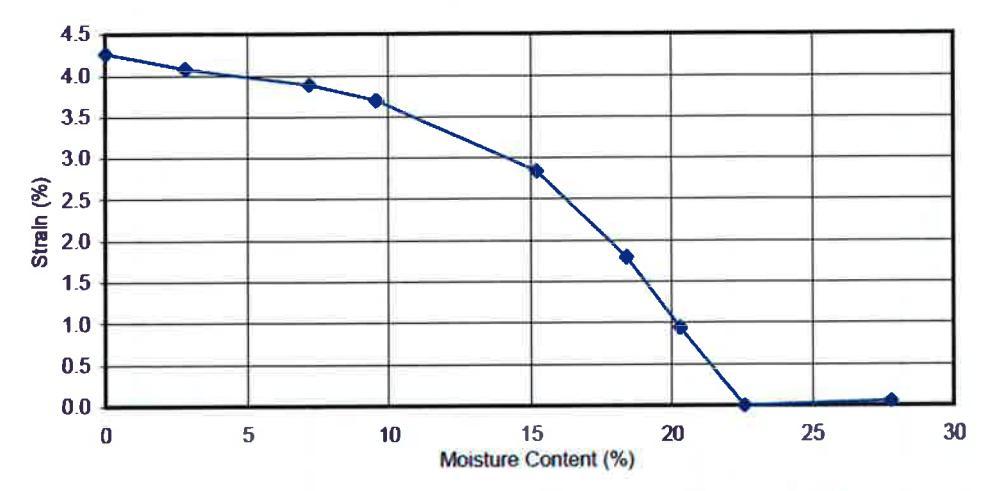
CORE SHRINKAGE T	EST	SWELL TEST		
Shrinkage - air dried	4.1 %	Pocket penetrometer reading at initial moisture content	230 kPa	
Shrinkage - oven dried	4.3 %			
		Pocket penetrometer reading	200 kPa	
Significant inert inclusions	Nil %	at final moisture content		
Extent of cracking	SC	Initial Moisture Content	25.2 %	
Extent of soil crumbling	5.0 %	Final Moisture Content	27.8 %	
Moisture content of core	22.6 %	Swell under 25kPa	-0.1 %

SHRINK-SWELL INDEX Iss 2.4% per ∆ pF

Decerintion:	Silby CLAV Light brown	
Description.	Sity CLAT-Light brown	
Test Method(s):	AS 1289.7.1.1 - 2003, AS 1289.2.1.1 - 2005	
Sampling Method(s):	AS 1289.1.3.1-1999	
Extent of Cracking:	UC - Uncracked	HC - Highly cracked
	SC - Slightly cracked	FR - Fractured
Remarks:	MC - Moderately cracked
